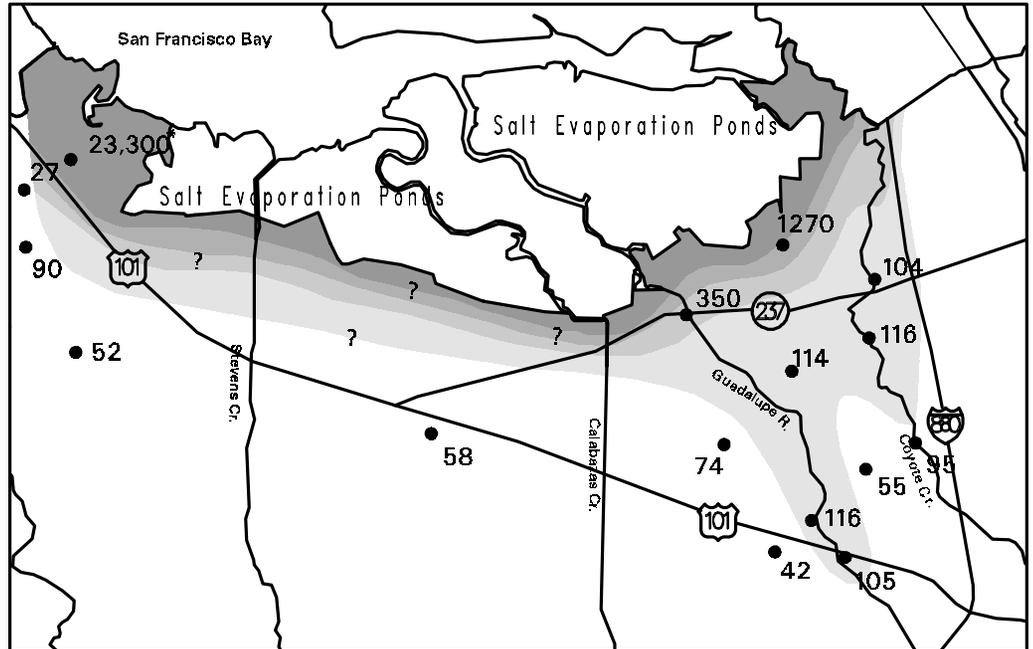
Figure 18: Saltwater Intrusion in the Upper Aquifer System of the Santa Clara Valley Basin
(Source: Santa Clara Valley Water District)
